A Case Study

Figure 1: A photograph of a complex industrial machine, likely a textile loom or weaving machine, featuring a large wooden frame, metal components, and a green mesh screen.

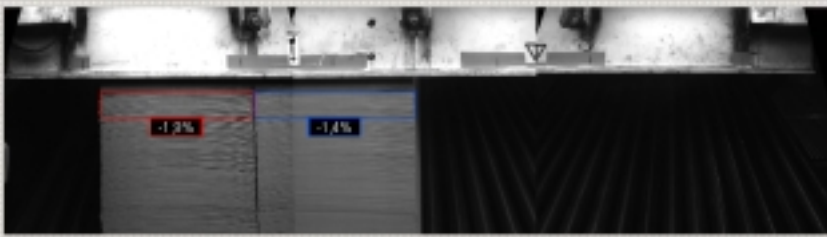
Warp graph for Upper Stacker showing warp percentage vs width (mm). The graph shows two distinct curves: a red curve peaking at -1.2% and a blue curve peaking at -1.4%.

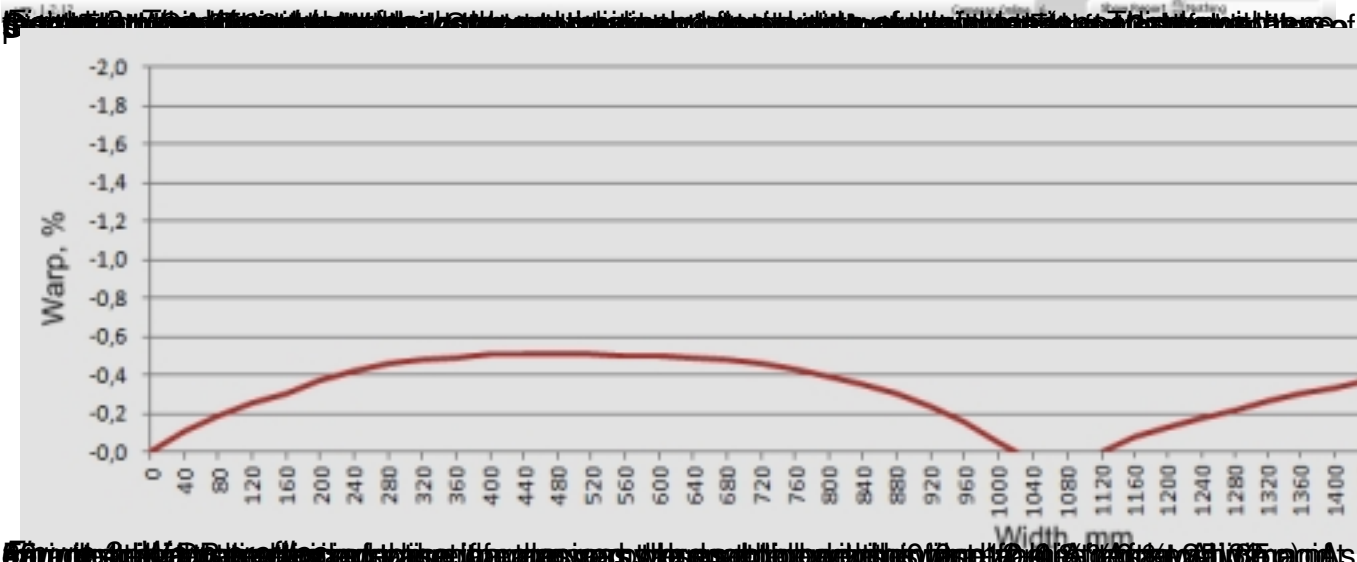
Figure 1: Warp Data for the Upper Stacker. The graph shows a significant warp of approximately -0.5% across the width of the stacker, with a peak of -1.55% at 400mm width.

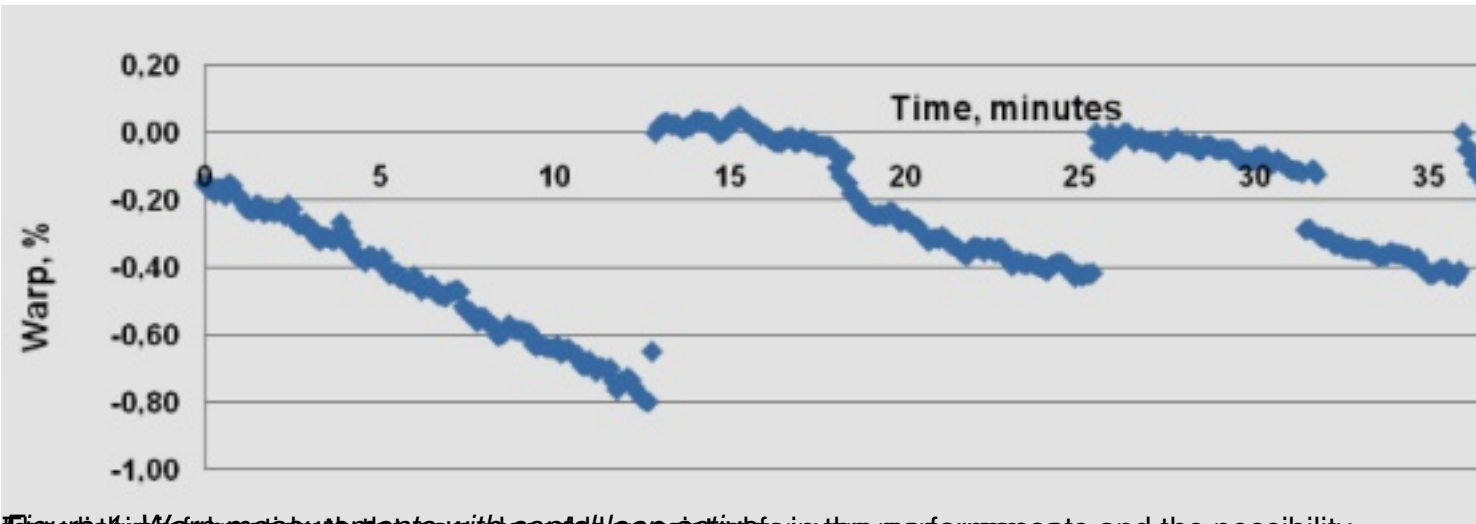
Figure 4.13. Warp measurements with closed loop control in the measurements and the possibility
